CASE REPORT

Mechanical complications with implants and implant prostheses

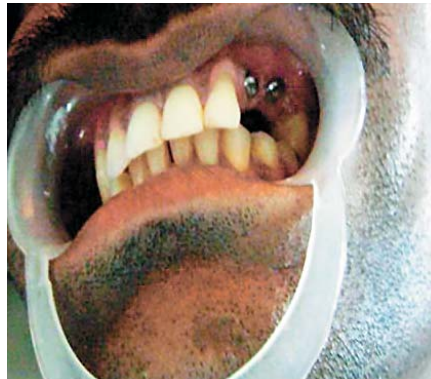
Figure 4: Gingival former placement at 6-month

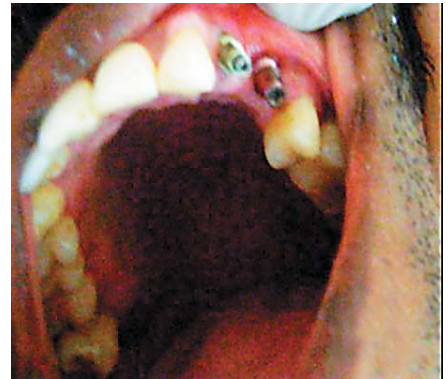
Figure 5: Abutment placement 23, 24 at 7 1/2 month

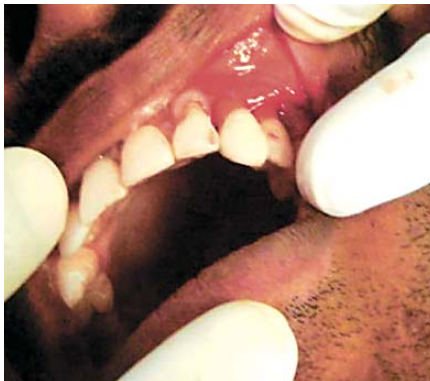
Figure 6: Insertion of crowns in 23, 24 regions.

Final ceramic crown prosthesis were placed in 23, 24 region (Fig6). 15 days after insertion, loosening of crown in relation to 24 was clinically seen (Fig7). IOPA radiograph of 24 revealed that a microgap between the abutment and the implant (Fig8). When the same abutment minus crown was retried, there was a microgap identified clinically between abutment & implant (Fig9). The case was recall for analysis of the problem & its rectification (Fig10).

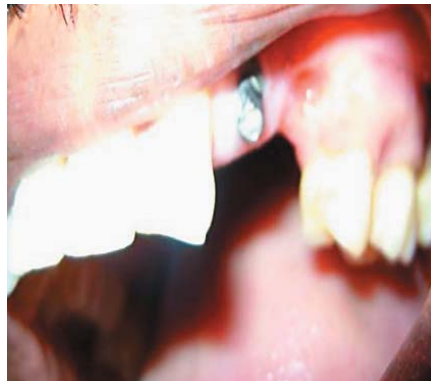
In the present case loosening of the abutment with the crown from implant was seen in the first premolar region. This may be due to (1) more sub crestal positioning of implant in that specific site (due to lack of bone density in that particular area), (2) improper positioning or fixation of abutment with the implant, or (3) over occlusive forces in the second premolar region which eventually lead to loosening of crown with 24. Proper fixation of the abutment with the implant is crucial to the success of the implant prosthesis⁶. Care should be taken to avoid improper fixation in order to prevent microgaps and loosening of prosthesis that might be due to excessive occlusal forces or improper positioning of abutment or screw loosening. Implant failures due to the above reasons can thus be avoided. Research and clinical results indicate that cautious timing of site preparation and implant placement, along with important concepts of implant spacing, can significantly reduce complications.⁷

Figure 7: Crown loosening seen in relation to 24 at 8 1/2 month recall.

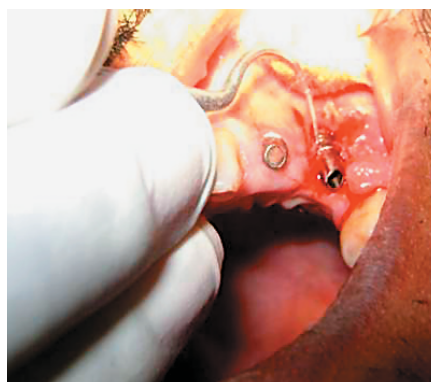
Figure 9: Microgap between Abutment & Implant of 24 detected clinically.
